Venezuela debris-flow and flash-flood disaster of 1999 studied

The Vargas Debris Flow-Flash Flood Disaster

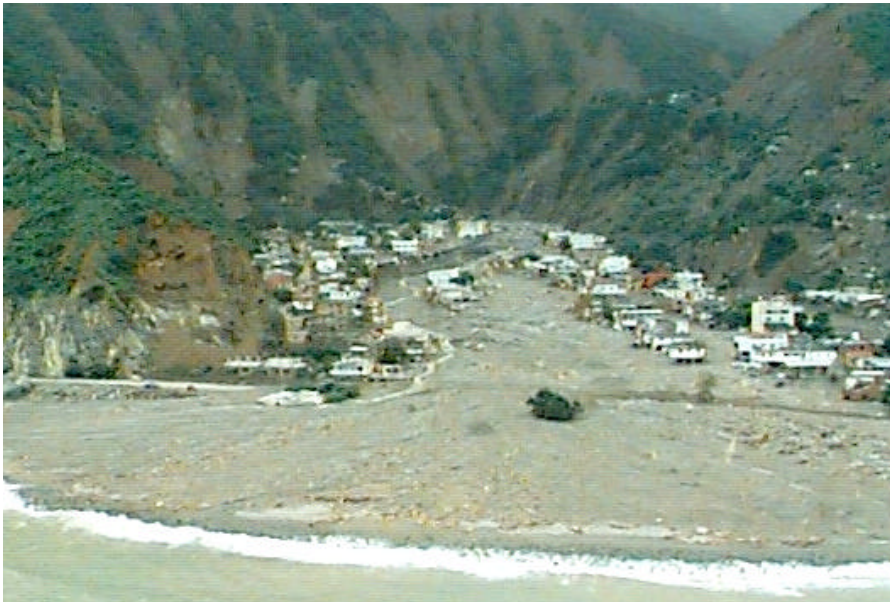
Figure 1. This aerial view shows the canyon and alluvial fan at Carmen de Uria, Vargas, Venezuela. Hundreds of buildings in the center of the alluvial fan were obliterated by debris flows on December 16-17, 1999, and the fan prograded seaward as much as 100 m.

Alluvial fans are defined as gently sloping, cone- to fan-shaped landforms created over thousands to millions of years by deposition of eroded sediment at the base of mountain ranges [NRC, 1997]. They are typically associated with arid to semi-arid environments such as that of the western United States; however, alluvial fans also occur in more humid environments as the Venezuelan example illustrates (Figure 1).

The Vargas coastal areas are home to highly urbanized neighborhoods with buildings ranging in size from single-story, un-reinforced masonry and concrete homes to multi-story, modern apartment buildings (Figures 1 and 2). Almost all of the structures are built on alluvial fans. Prior to the 1950s, the alluvial fans on which these neighborhoods are constructed were used for agriculture and population density was low. The Cordillera de la Costa uplands are part of El Avila National Park, a forested preserve with minimal human disturbance, although a few unpaved roads parallel the ridgeline of the mountains. The north boundary of the park is marked by the slope break at the seaward base of the mountains.

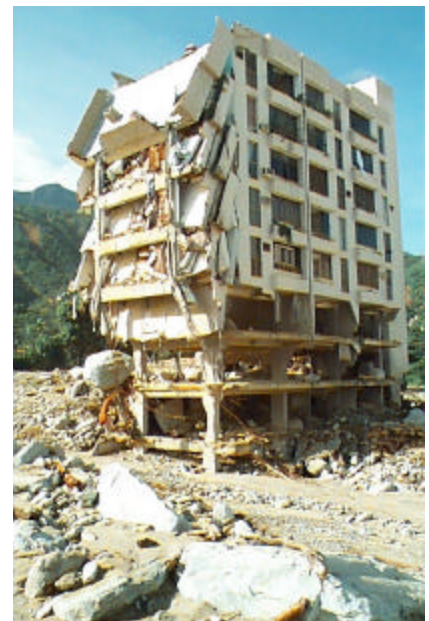
Figure 2. Debris flow damage to an apartment building in Caraballeda, Vargas, Venezuela, occurred in December 1999. Debris flows passed through the first two stories of this building.
