# THE RAINFALL-TRIGGERED LANDSLIDE AND FLASH FLOOD DISASTER IN NORTHERN VENEZUELA, DECEMBER 1999

By M.C. Larsen, Hydrologist, (1) G.F. Wieczorek, Engineering Geologist, (2) L.S. Eaton, Geologist, (3) H. Torres-Sierra, Hydrologist, (1)

**Abstract:** Rainstorms in December 1999 induced thousands of landslides along the northern slopes of the Cordillera de la Costa mountain range principally in the state of Vargas, Venezuela. Rainfall accumulation of 293 millimeters during the first 2 weeks of December was followed by an additional 911 millimeters of rainfall on December 14 through 16. The landslides and floods inundated coastal communities resulting in a catastrophic death toll estimated at between 15,000 and 30,000 people. Debris flow damage to houses, buildings, and infrastructure in the narrow coastal zone was severe. Flash floods on alluvial fans at the mouths of rivers draining the coastal mountain range also contributed to the general destruction.

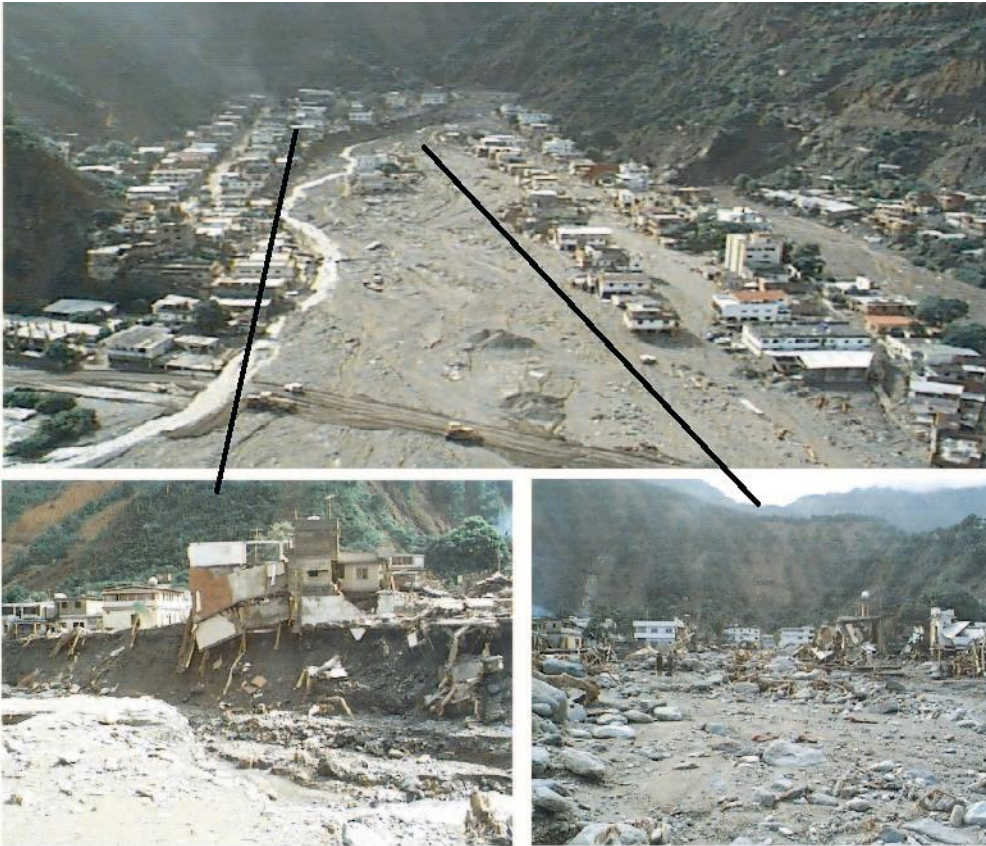
Figure 3. Aerial and ground views showing debris flow and flash flood damage at Carmen de Uria, January 2000.

Carmen de Uria is a small community dominated by lower-income housing built on a narrow alluvial fan between steep canyon walls at the mouth of an 11.9 km<sup>2</sup> watershed (fig. 2). Dozens of homes in a section of the central fan were obliterated by debris flows that survivors said occurred in two to three episodes between midnight and 9 am on December 16 (fig. 3). Before that date, the large open area, visible in figures 2 and 3 had a housing density comparable to that seen in the southeast section of figure 2.

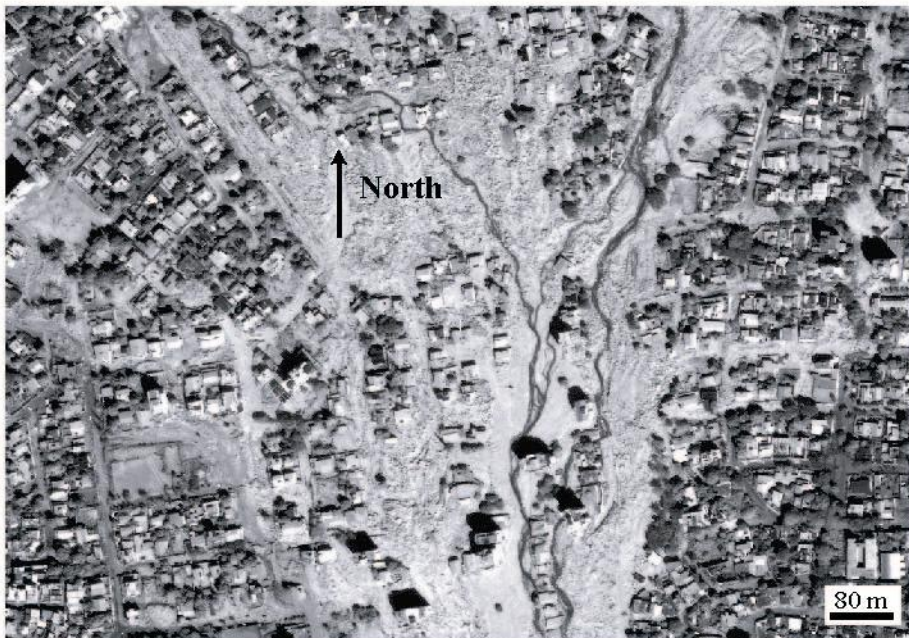
Figure 4. Aerial image taken after December 1999 event showing the Caraballeda fan and destruction of the Los Corales community. Image courtesy of F. Urbani, Universidad Central de Venezuela.

On the Caraballeda alluvial fan, 10 km west of Carmen de Uria, extensive property destruction occurred (figs. 4,5). Approximately 1.25 million m<sup>3</sup> of debris flow deposits, which included numerous massive boulders up to 10 m long, were distributed across several square kilometers of fan surface resulting in a deposit thickness of up to 4 m (fig. 5). Small structures were reduced to rubble in many cases and large, multi-story apartment buildings sustained heavy damage (fig. 6). The thickness of debris flow deposits measured at locations within 150 m of the current shoreline averaged 1.5 to 2 m, and the diameter of the largest boulders (D<sub>90</sub>) at sites near the shoreline was on the order of 1 m. An estimated 450,000 m<sup>3</sup> of sediment was deposited in a 1,000-m wide subaerial delta with an average seaward extent of 50 m, assuming the same 20 degree submarine slope used for the estimate at Carmen de Uria.

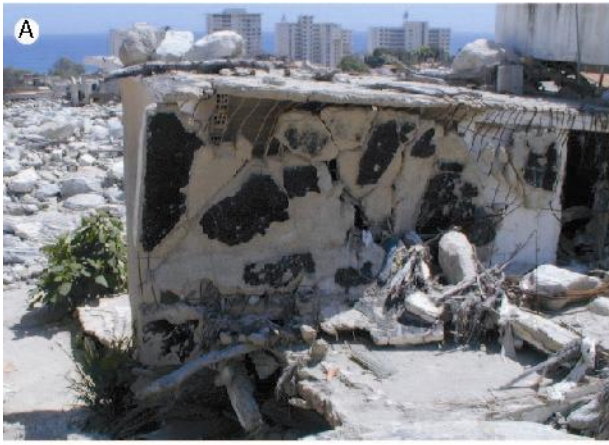
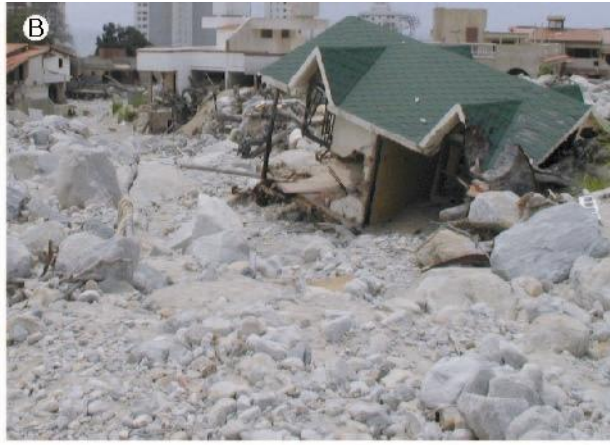
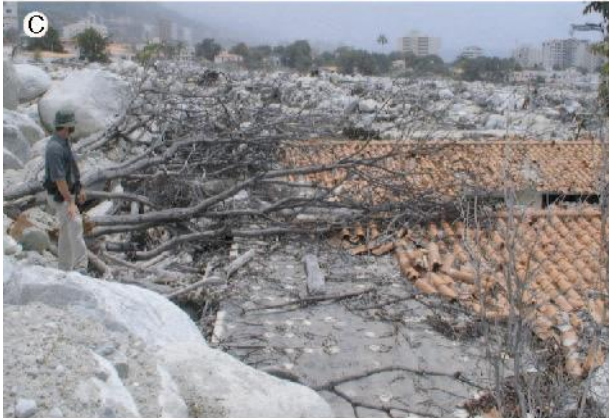
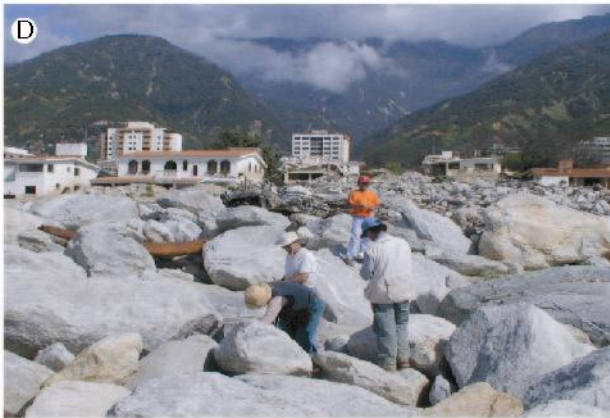
Figure 5. Debris flow deposits on the Caraballeda fan. (A) House with 1-m diameter boulders on roof. (B) Concrete house rotated off foundation by debris flow. (C) View across debris fan; tiled surface on right is top of one story home. (D) View up debris fan looking towards San Julián canyon.

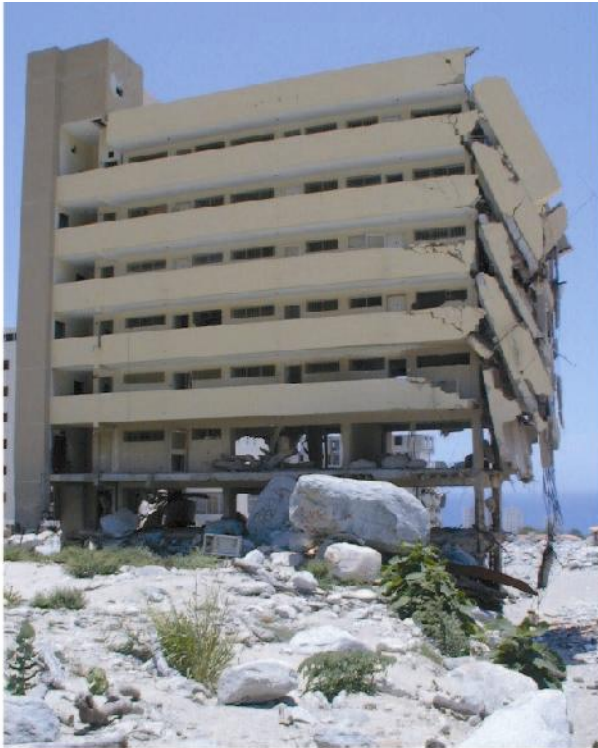
Figure 6. Apartment building damaged by debris flows, Caraballeda. Note collapsed apartments and boulders on floor of second story.

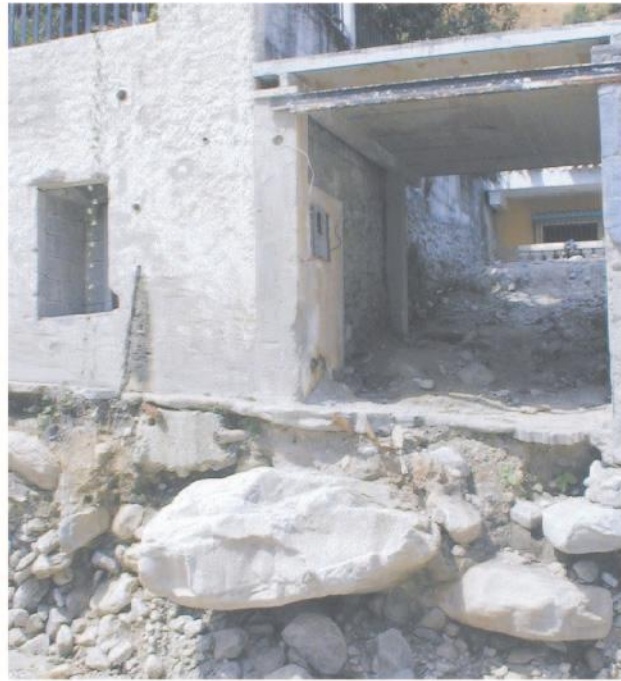
Figure 7. House and garage on Caraballeda fan with exposed foundation showing old debris flow deposit.

Exposures of old debris flow deposits were ubiquitous along canyon walls and on dissected alluvial fan surfaces (figs. 7,8). These deposits are strong physical evidence for the episodic recurrence of debris flow events in the Cordillera de la Costa. Deposits from a high-magnitude prehistoric debris flow event were observed in a number of watersheds (fig. 8). The deposits included massive boulders, larger than those moved in the December 1999 event, and indicate that although the 1999 event was rare, a more extreme storm event occurred in prehistoric time.

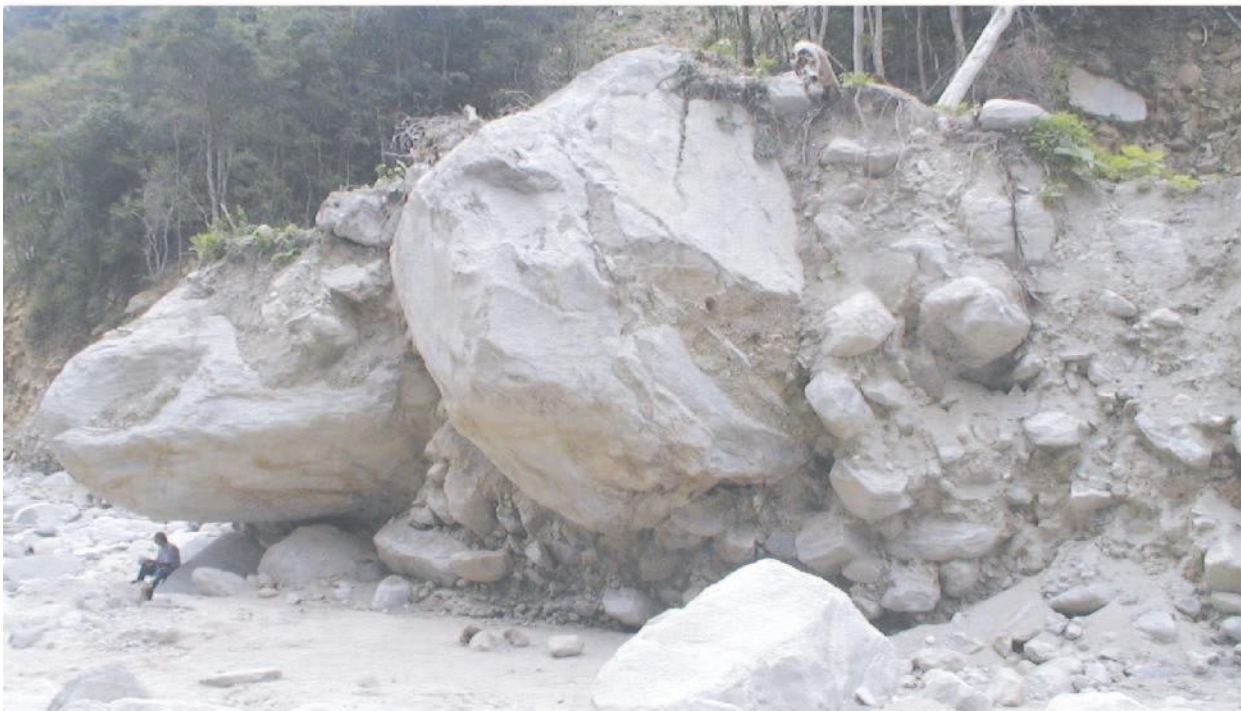
Figure 8. Massive boulders deposited by ancient debris flow in the Río San Julian valley, approximately 2 km upstream of Caraballeda. The boulders were exposed by the December 1999 event. Their dimensions exceed that of the largest boulders moved in December 1999. Note person on left for scale.
