**NATURAL HAZARDS ON ALLUVIAL FANS: THE DEBRIS
FLOW AND FLASH FLOOD DISASTER OF DECEMBER 1999,
VARGAS STATE, VENEZUELA**

M.C. Larsen¹, G.F. Wiczorek², L.S. Eaton³, and Heriberto Torres-Sierra¹

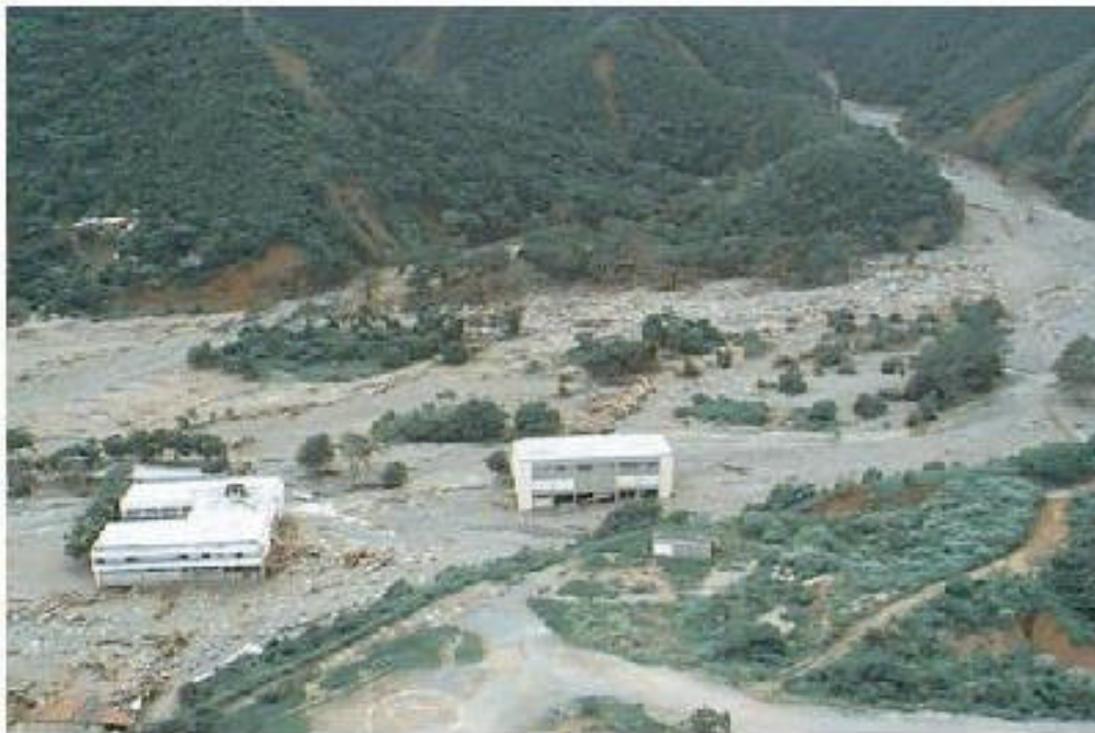
FIGURE 3. Aerial view of upstream portion of alluvial fan at Camuri Grande, Vargas, Venezuela, showing buildings damaged by flash floods at regional campus of Universidad Simón Bolívar, January 2000.

Flash floods, hyperconcentrated flows, and debris flows occurred in the canyons and alluvial fans of most of the several dozen small catchments (watershed areas on the order of 10 to 30 km²) that drain the coastal mountain range (figs. 3, 4). Residents with homes on the alluvial fans described multiple high stream flows and debris flows that began late on the night of December 15 and continued until the afternoon of December 16. Although the alluvial fans showed evidence of massive debris flows, most also contained laminar, well-stratified flood deposits, indicating that both flood and debris flow processes were common.

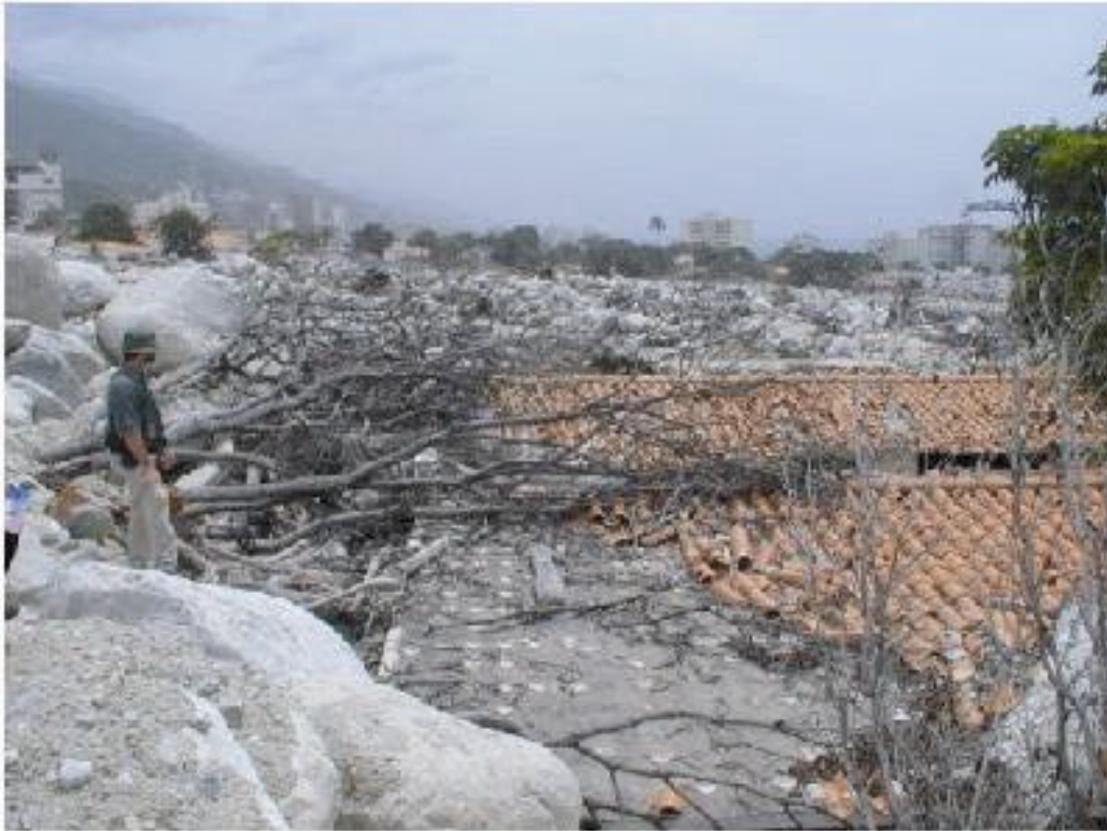
FIGURE 4. Debris flow deposits on alluvial fan, Los Corales sector of Caraballeda, Vargas, Venezuela. Structure in foreground is tiled rooftop of one-story house, July 2000.

A combination of debris flows that transported massive boulders, and flash floods carrying extremely high sediment loads were the principal agents of destruction (fig. 4). On virtually every alluvial fan along the Vargas coastline, rivers incised new channels into fan surfaces to depths of several meters, and massive amounts of new sediment were disgorged upon fan surfaces in quantities of up to 15 metric tonnes per square meter. Sediment size ranged from clay and sand to boulders as large as 10 m in diameter. Sediment and debris including massive boulders were deposited up to several meters thick across large sections of alluvial fans in Camuri Grande and Caraballeda (figs. 3, 4). Hundreds of houses, bridges and other structures were damaged or destroyed. Residents had little advance warning of the debris flows and flash floods that struck in the early hours of December 16, so many were caught in their homes and their bodies were carried out to sea or buried by the flood debris.
